# Manhole Inspection Summary

Manhole # S13G1\_005MH

Insp Date: **12/22/08 11:46 AM**

**Location** Address: **S.Caton Ave**

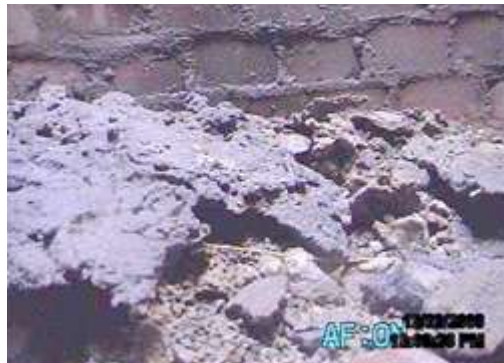
Defect 5

Comments **debris on the bench blocking view of 12 o clock pipe seal**

Condition: ☐ Sound ☐ Cracked ☐ Root Intrusion ☐ Deteriorated ☐ Leaks ☒ **Debris**

debris on the bench

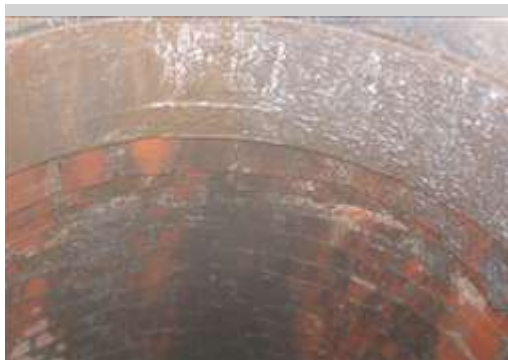
Defect 4

**Frame** Offset: **0** (in.) Condition: ☐ Sound ☐ Cracked ☒ **Leaks**

frame, chimney and corbel infiltration

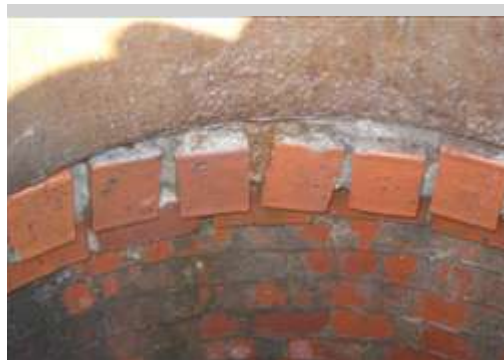
Defect 2

Condition: ☐ Sound ☐ Cracked ☐ Root Intrusion ☒ **Loose Brick** ☐ Deteriorated

Infiltration: ☐ None ☐ Joint ☐ Cracks ☒ **Mortar** ☐ Roots ☐ Wall

missing mortar causing chimney infiltration

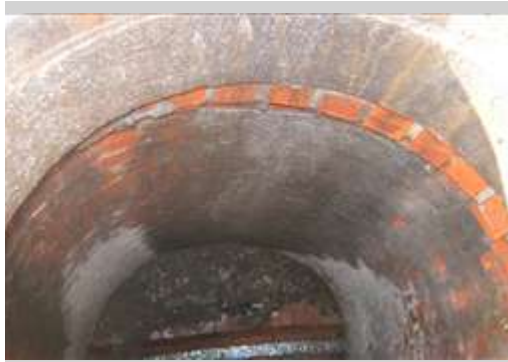
### Defect 1

Infiltration: ☐ None ☐ Joint ☐ Cracks ☐ Mortar ☐ Roots ☒ **Wall**

corbel infiltration

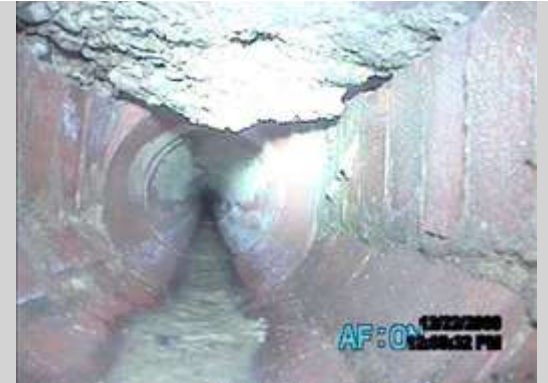
12 O'Clock Outflow

Pipe Height: **8.4** (in.) Rod and Bar (Angled)  
Pipe Material: **Clay** ☐ Pipe Lined  
Invert Depth: **8.82** (ft.) Flow Characteristics: **None**  
Deposits: ☒ None ☐ Mud ☐ Sludge ☐ Debris ☐ Grease  
Silt Depth: **0** (in.) Deposits Extent:  
Infiltration: **None** Pipe Seal Cond: **Sound**

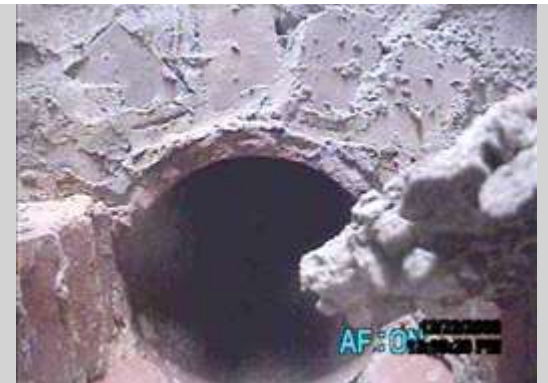
6 O'Clock Inflow

Pipe Height: **8.4** (in.) Rod and Bar (Angled)  
Pipe Material: **Clay** ☐ Pipe Lined  
Invert Depth: **8.71** (ft.) Flow Characteristics: **None**  
Deposits: ☒ None ☐ Mud ☐ Sludge ☐ Debris ☐ Grease  
Silt Depth: **0** (in.) Deposits Extent:  
Infiltration: **None** Pipe Seal Cond: **Sound**
